# Thread Fixing

## Keeping it tight and together with threaded inserts

By Bruce Smith

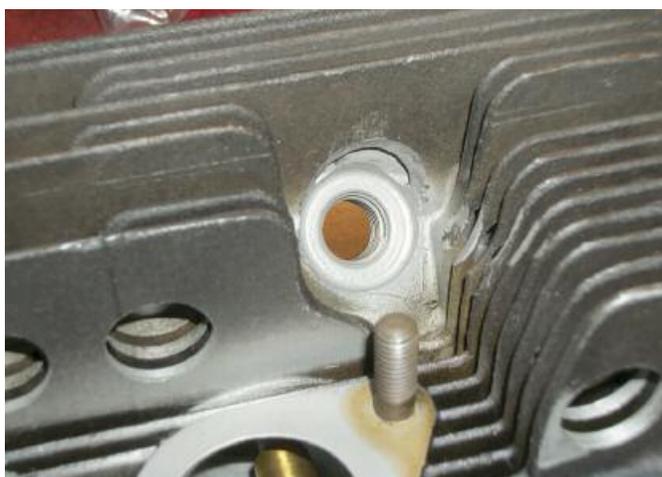
Spark plug holes in our 356/912 motors use threaded coil inserts from the factory.

Our beloved Porsche engines use helical inserts to strengthen the threaded holes in the heads for spark plugs. These holes were bored then tapped with v-shaped threads for insertion of a coiled wire insert, like the one in the diagram above. During insertion, the wire expands into the threads to form a hard metal thread lining to become an integral part of the bore. The photo below shows a coil insert lining the plug hole in a typical 356/912 head.

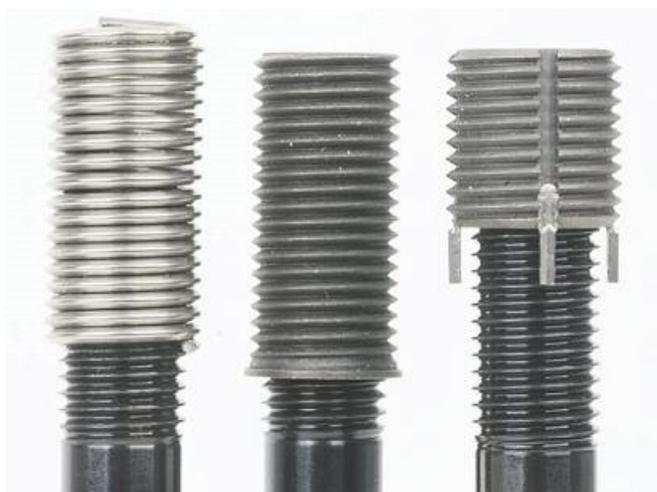
Three options for thread repair: a Heli-coil insert (left) and external thread inserts, Time-sert (center) and Keen-sert (right).

There are other options to strengthen internally threaded holes. External thread inserts, such as the Time-serts or Keen-serts shown below, are solid metal bushings that are threaded both inside and out. When installed with a special driver, they are screwed into a tapped hole to complete the thread cutting and secure them in place. They are generally larger than helical inserts, which can limit their application in tight spaces. Since they are solid, these can be secured with a thread sealer, something that shouldn't be done with wire inserts since both sides of the threads would become coated.

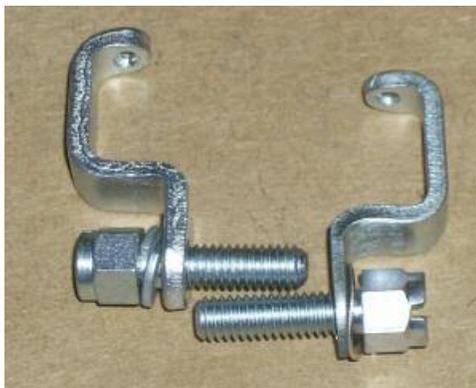
Thinning the carburetor spring clamp and using a thinner washer (right) can gain a few more threads into a carburetor body.

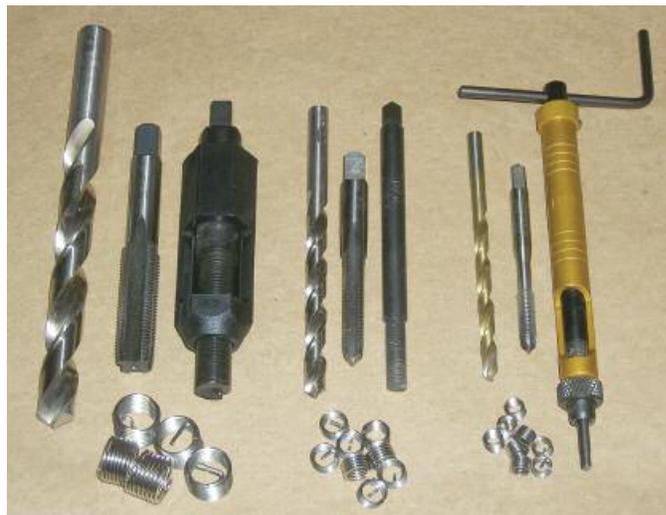
Three helical insert sets for thread repair: M12x1.25mm for carburetor fuel ports (left), M7x1mm for jet cover bolts (center) and M5x0.90mm for Zenith cover top screws (right).

So a more permanent fix is desirable. If a threaded hole in the soft alloy were secured with a thread insert to begin with, the problem would not have occurred. So the best fix now is to use a thread insert. In this case, because of the limited space available around the screw hole, a Heli-coil is a better choice than an external thread insert. The basic repair approach is fairly simple: drill to size, tap to the necessary thread, screw in the insert, and then shear off the tang. But each step is critical with opportunities for error. The first thing to think about are the necessary tools. For Heli-coil type inserts, there are a few options. You can find a cheap import kit that will cover all standard metric sizes between M5 and M10 with all the bits, taps, inserts, and tools for less than \$50. This is a perfect example of 'you get what you pay for'. Don't be tempted. Inserts are really a one-chance deal and if it goes wrong they're nearly impossible to re-do, especially when repairing a blind hole. Use quality kits and parts from reputable suppliers, like the ones shown below. These examples include properly sized drill bits, taps, insertion tools, and the corresponding coil inserts.

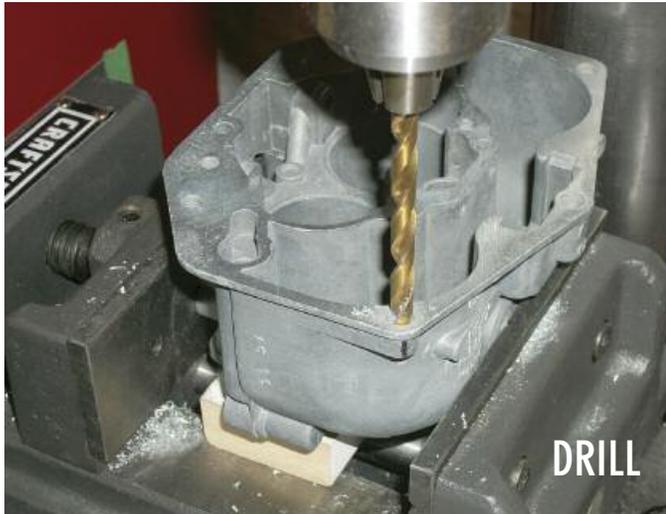
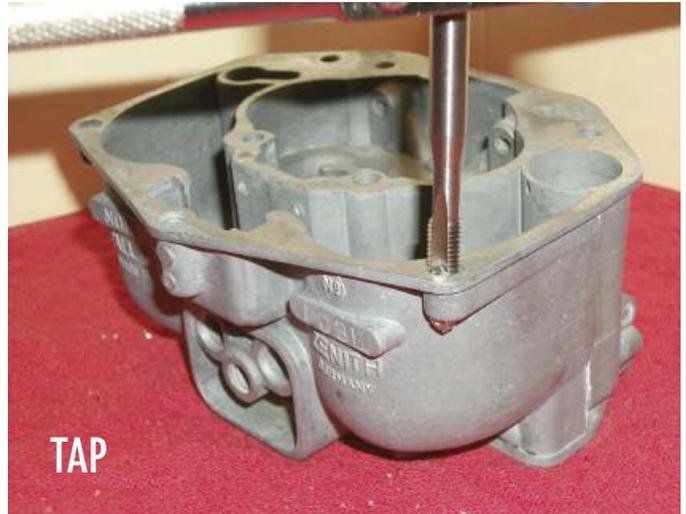
The sequence for repairing a threaded hole using a Heli-coil style insert.

The sequence for repairing Zenith cover holes can be seen in the photos that follow. These are through-holes but the technique is similar for blind-holes. The inserts require a specific bit size to bore and a tap that corresponds to the external size and pitch of the wire coil. When drilling, it's important that the new bored hole is centered and perpendicular to the reference surface (here the carb top). This will be especially important when repairing a thread used for sealing, like those for the jet covers and fuel lines. Fuel leaks are guaranteed if the insert isn't perpendicular. The right tap to use will be furnished with the kit. Since the body is a soft alloy, cutting fluid during drilling/tapping isn't necessary but can be used. Now comes the trickier part. When inserting the coil, you'll need to ensure that it starts correctly and follows the tapped threads. If any resistance is met, an insert can usually be backed out if it isn't fully seated and the tag removed. It's important that the wire follow the threads, otherwise they will become crossed. The length of the coil should be sufficient to fill all threads and coils can be shortened from longer ones if needed. Once the coil is fully inserted, which should be just below the top surface, its tang is broken off with a sharp tap from a small rod inserted into the hole. The last photo shows a repaired hole together with the Zenith top cover screw.
